WARRANTOR: **MANUFACTURING SUPPLIERS LTD (MSL)**

Product Name	Wall Bracing(kN)*	Retro Pile Fixing(kN)**
95mm FORTRESS® BRACING BRACKET	4.22	17.4

**TEST CERTIFICATE No.: INZ45438-02**

**TEST CERTIFICATE No.: INZ46432-01**

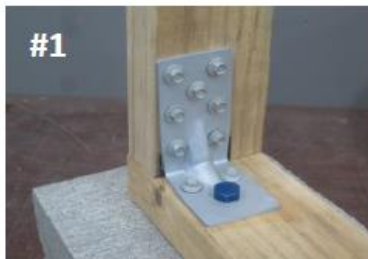
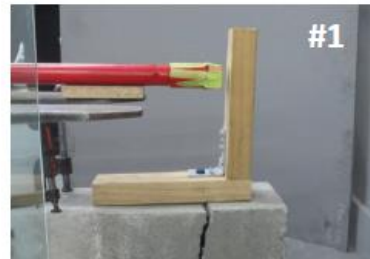
Client: Fortress Fasteners  
 Order No.: Daniel  
 Sample Description: Timber / bracing bracket assembly as supplied  
 Identification: As below  
 Material Specification: Not supplied  
 Tested in accordance with: As per client instruction

**TEST:** Load has been applied to the fixed assembly as per below setup.  
 Maximum load achieved was recorded.

Samples as supplied

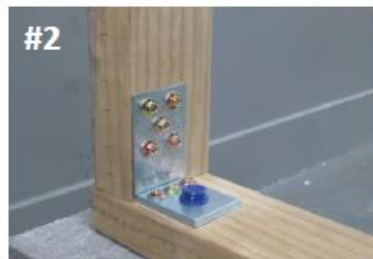
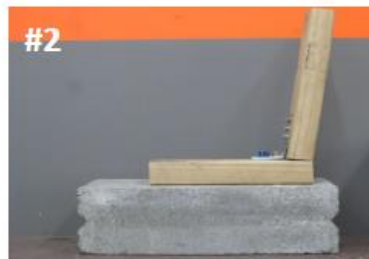
Sample ID	Maximum load (kg)	Findings
# 1	430	Concrete base fractured, bracket slightly deformed
# 2	260	Bracket heavily deformed

Samples after the test

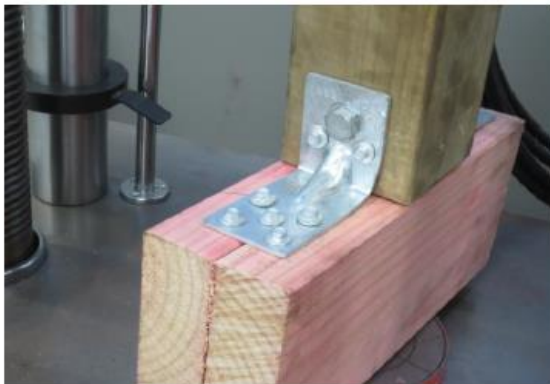
**TEST:** Two 140x45mm bearers placed side-by-side were fixed by two connectors on each side of 100x100mm pile. The assembly was prepared by the client.

Load was applied along the axis of the pile to separate the assembly.  
 Maximum breaking load of the connection was recorded.

Assembly setup

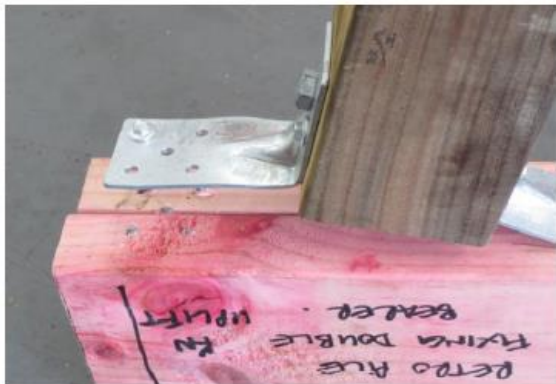
Maximum breaking load: 17.4 kN  
 Findings: Screw head sheared off

Failure after loading
